PMA Consultants

NAFS Photo Log 03.26.2021

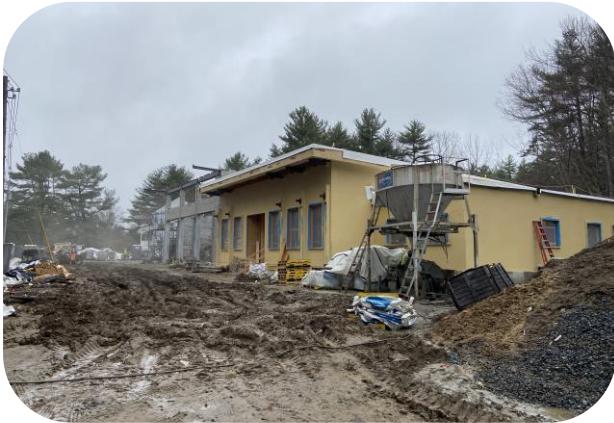
Overview of east side

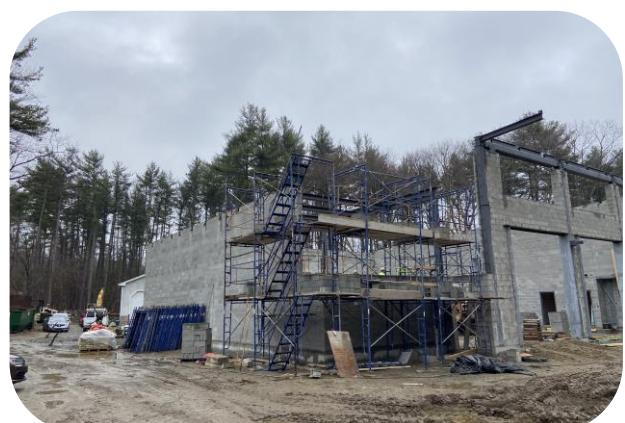
Overview of building from southwest side of site

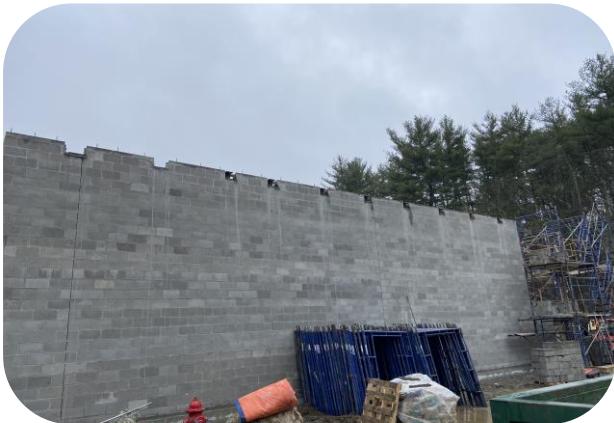
Masonry construction along west side of building

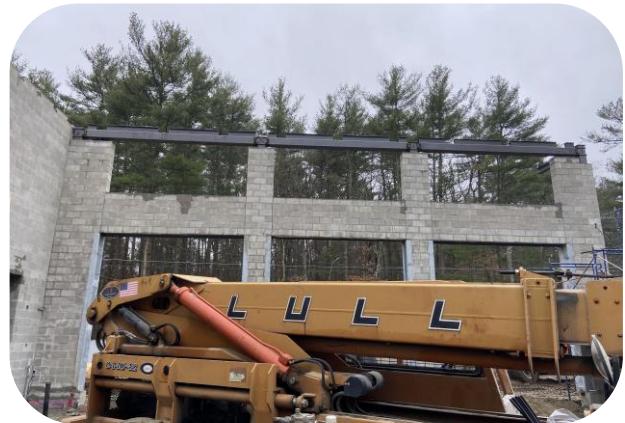
Overview of interior southern apparatus bay

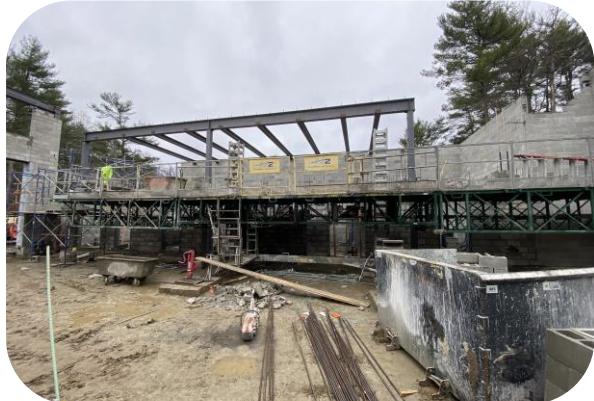
Masonry construction on western mezzanine

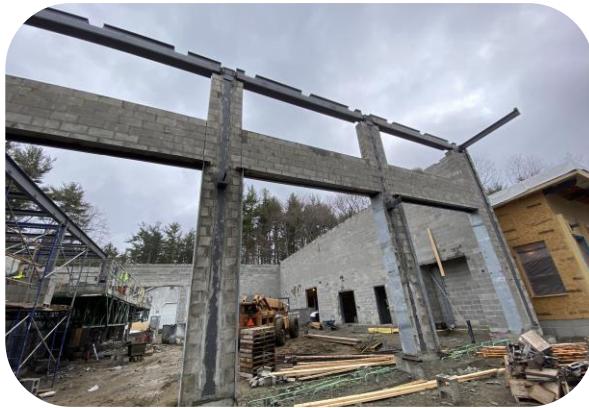
Southern apparatus bay exterior face

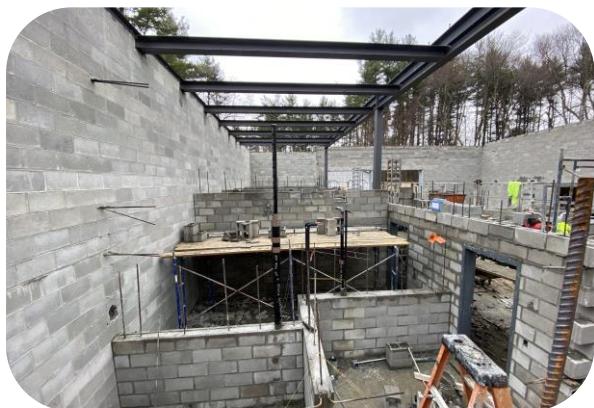
Overview of western mezzanine construction

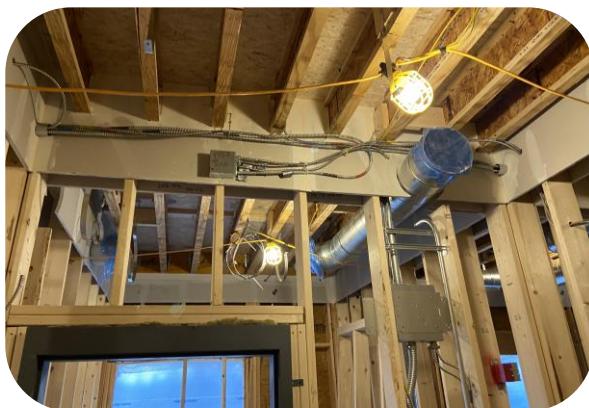
Wiring and HVAC rough-ins in bunk area

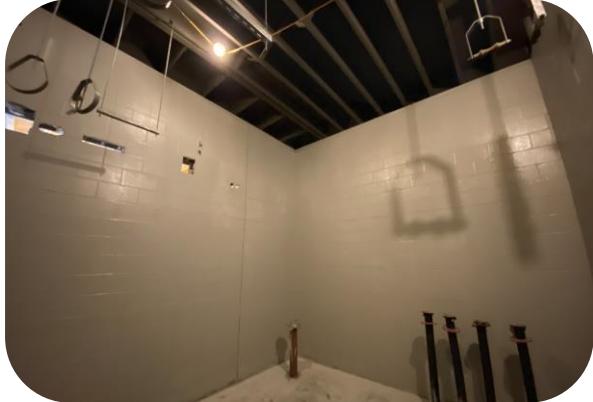
Painted mechanical room

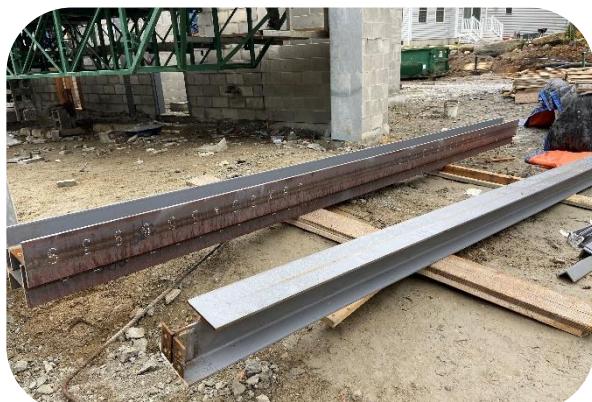
Western mezzanine steel beams

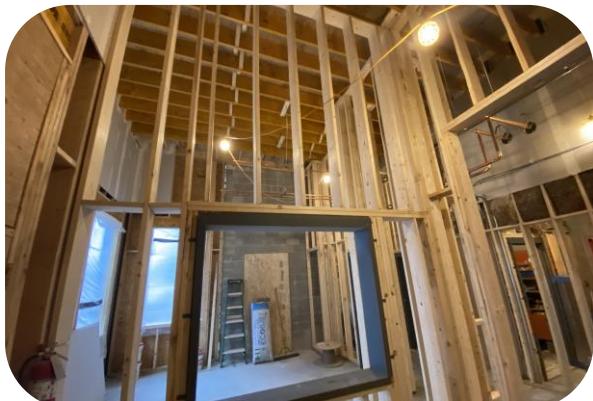
Interior framing at southern entrance

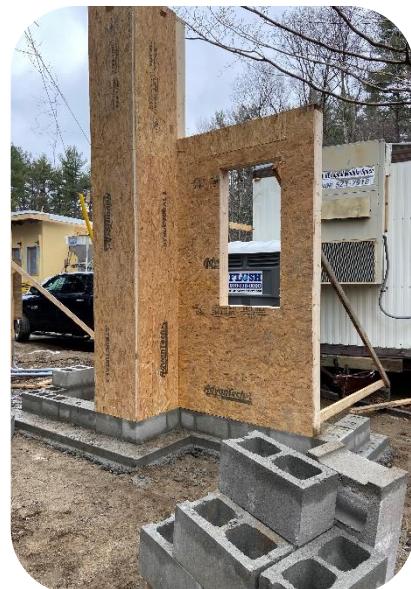
Mockup at job site trailer

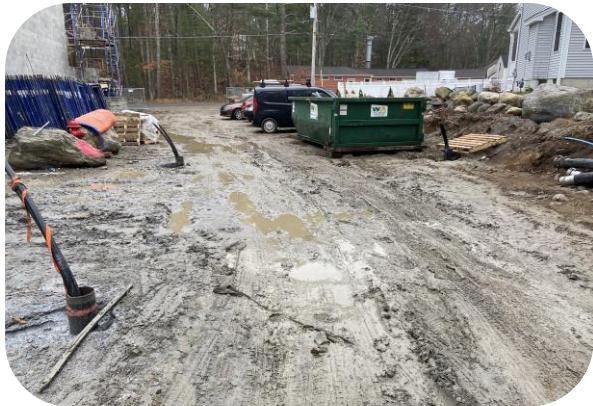
Grouted geothermal wells

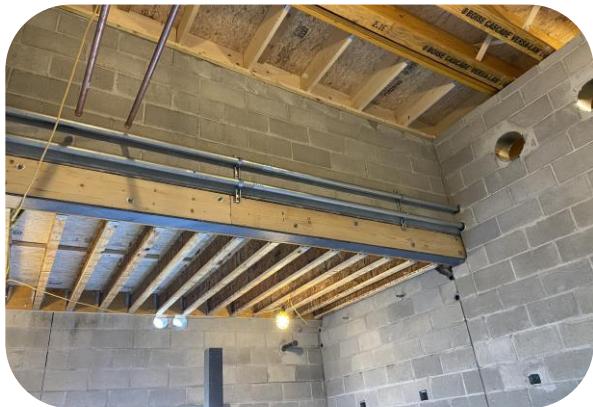
Ledger over gear room (03.23.2021)

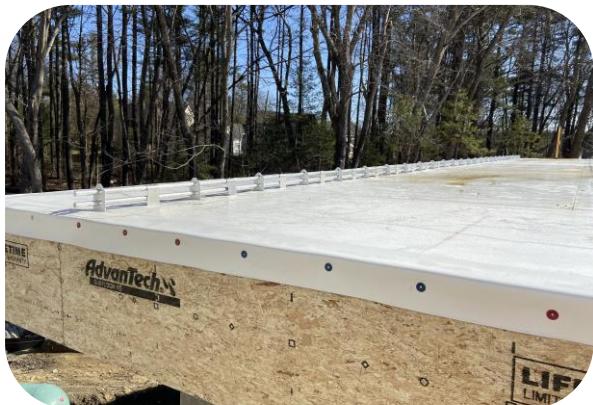
Snow fence on admin side sloped roof.
Roofing installed (03.23.2021)

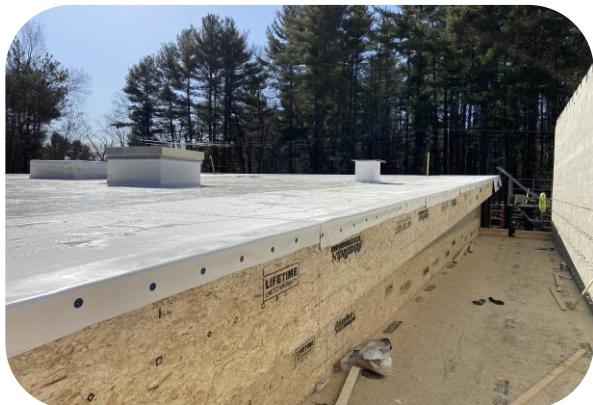
Roof hatch installed on admin side sloped
roof. Roofing installed (03.23.2021)
